Manhole Inspection Summary

Manhole # S25II1016MH

Location Address: **4223 HICKORY AVE**

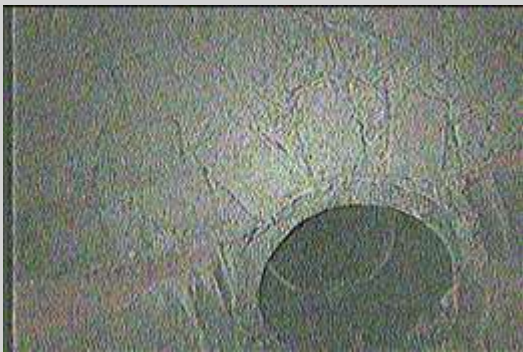
8 in. Circular Gravity Sewer Pipe Out @ 12 O'Clock

Invert Depth: **13.23** (ft.) Flow Characteristics: **Slow**

Infiltration: **None** Pipe Seal Cond: **Unknown**

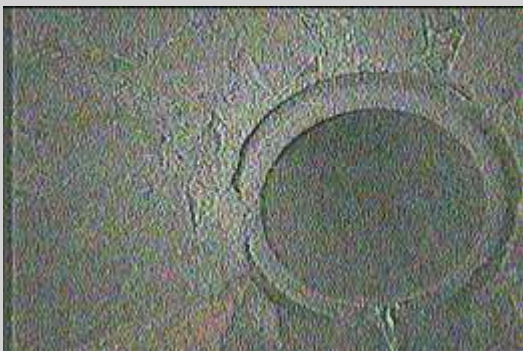
6 in. Circular Gravity Sewer Pipe In @ 3 O'Clock

Infiltration: **None** Pipe Seal Cond: **Unknown**
